**Flood Control Project Maintenance
Levee Inspections**

2018 Channel Summary Report

Fairfield Suisun Sewer District

Flood Control Project Maintenance**Unit Cover Sheet****2018 Channel Inspection Results****Fairfield Suisun Sewer District**

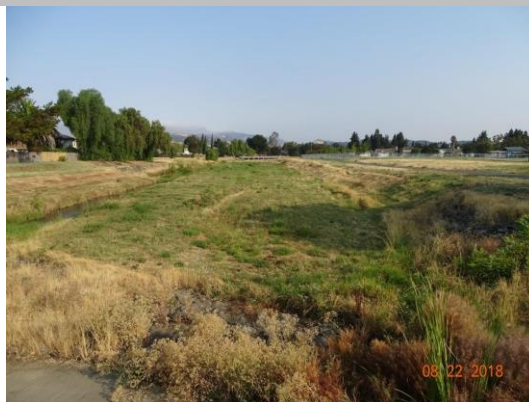
Photo 1 of 5 : CH_2018_NA0035_15_1_20180823_00090.jpg

View of the channel looking upstream. Summer 2018.

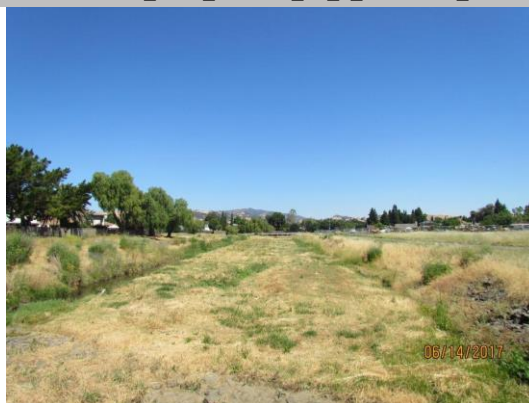
Photo 2 of 5 : CH_2018_NA0035_15_1_20180529_00001.jpg

View of Laurel Creek, looking upstream towards Gulf Drive from Cement Hill Road. Summer 2017.

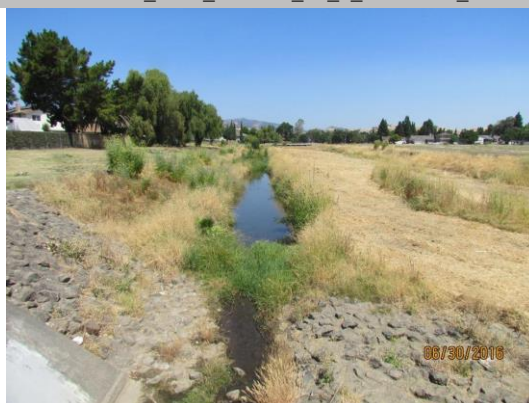
Photo 3 of 5 : CH_2018_NA0035_15_1_20180529_00002.jpg

View of Laurel Creek looking upstream towards Gulf Dr. from Cement Hill Road. Summer 2016.

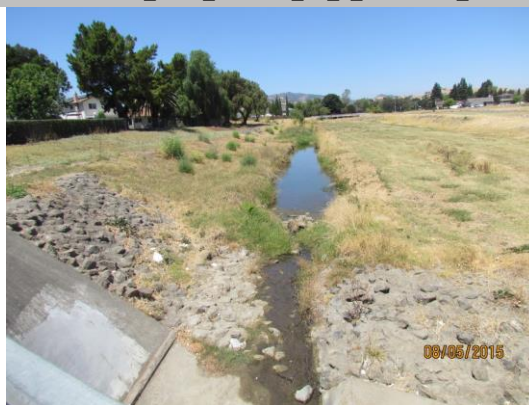
Photo 5 of 5 : CH_2018_NA0035_15_1_20180529_00004.jpg

View of Laurel Creek looking upstream. Summer 2015.

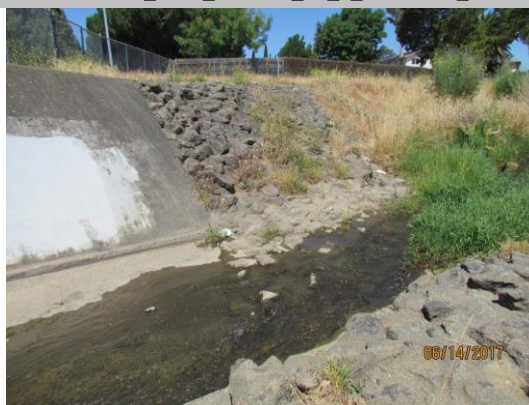
Photo 1 of 1 : CH_2018_NA0035_15_4_20180529_00005.jpg

Inspector Comments: Existing riprap protection is properly maintained and is undamaged. Riprap clearly visible.

View of revetment on right bank, looking upstream. Summer 2017.

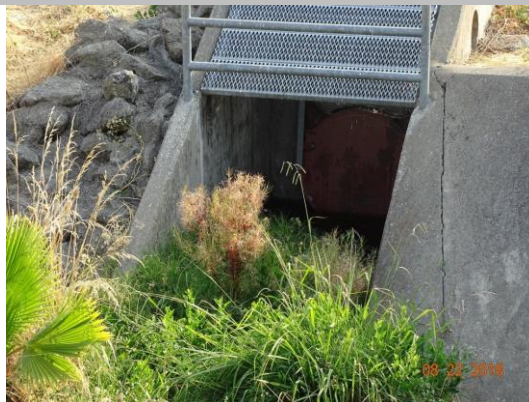
Photo 1 of 2 : CH_2018_NA0035_15_91_20180823_00089.jpg

Inspector Comments: Minimal debris is present, however nothing appears to obstruct the function of the gate.

View of the gate located on the upstream side on the left bank of the channel. Summer 2018.

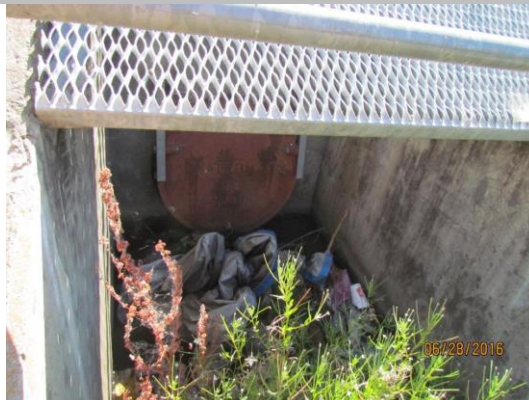
Photo 2 of 2 : CH_2018_NA0035_15_91_20180529_00067.jpg

Inspector Comments: Minimal debris is present, however nothing appears to obstruct the function of the gate.

View of the gate located on the upstream part of Laurel Creek from Cement Hill Rd. Summer 2016.

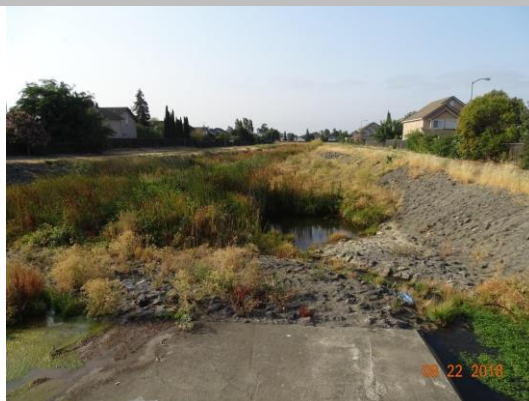
Photo 1 of 4 : CH_2018_NA0035_15_6_20180823_00086.jpg

View of the channel looking downstream. Summer 2018.

Inspector Comments: Cattails need to be removed.

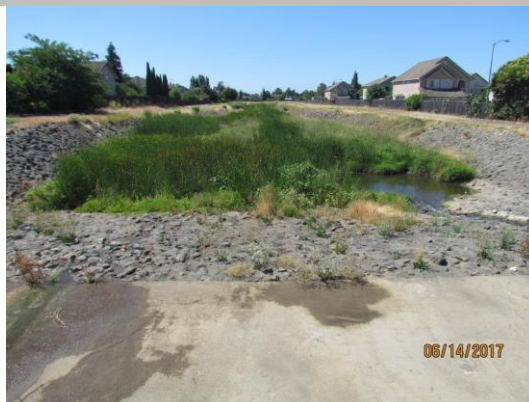
Photo 2 of 4 : CH_2018_NA0035_15_6_20180529_00006.jpg

View of channel looking downstream from Cement Hill Road. Summer 2017.

Inspector Comments: Cattails need to be removed.

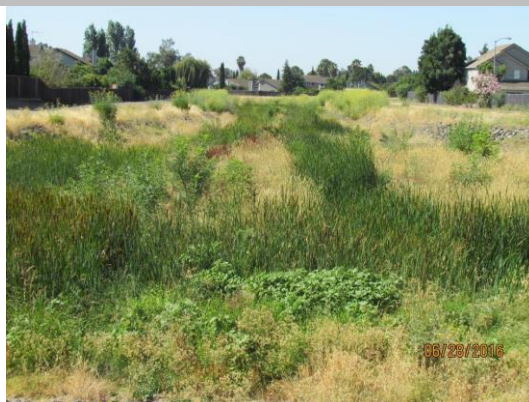
Photo 3 of 4 : CH_2018_NA0035_15_6_20180529_00007.jpg

View of the creek looking downstream from Cement Hill Rd. Summer 2016.

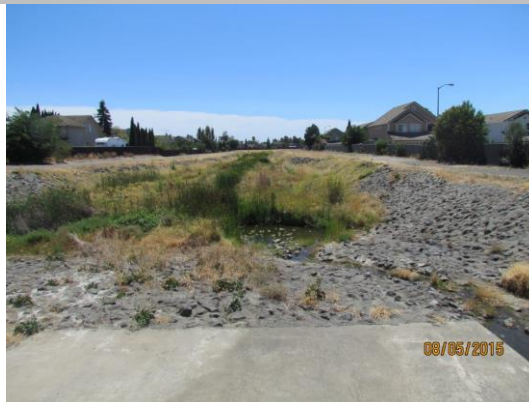
Photo 4 of 4 : CH_2018_NA0035_15_6_20180529_00008.jpg

Looking downstream from Cement Hill Rd. Summer 2015.

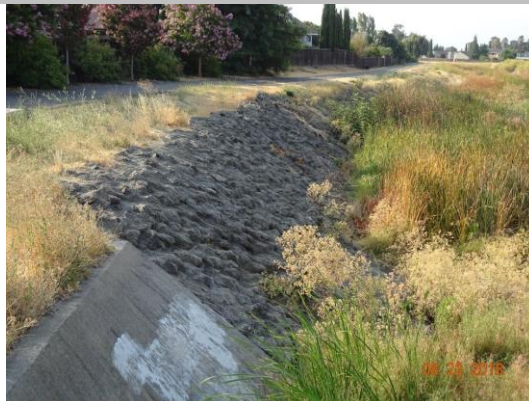
Photo 1 of 2 : CH_2018_NA0035_15_9_20180823_00087.jpg

Rating **	A	Issue No.	9	GPS Lat/Long
Issue Type +	Ma	Location *		38.279937 °
Category	Rivers, Channels & Designated Flood			-122.018354 °
Item	Revetments			
DWR ID	DWR_NA0035_15_c_2012_9			
Action/Comments				
Inspector Comments: Existing riprap protection is properly maintained and is undamaged. Riprap clearly visible.

View of the revetment on the left bank, looking downstream. Summer 2018.

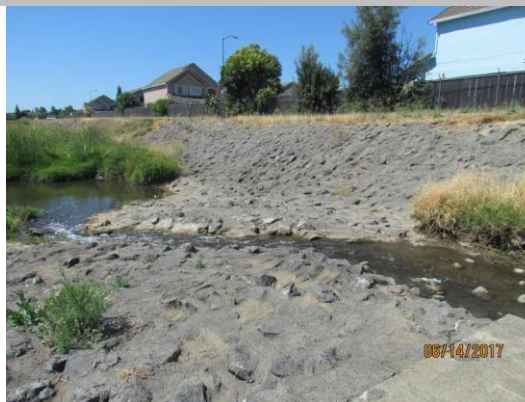
Photo 2 of 2 : CH_2018_NA0035_15_9_20180529_00009.jpg

Rating **	A	Issue No.	9 (cont)	GPS Lat/Long
Issue Type +	Ma	Location *		38.279937 °
Category	Rivers, Channels & Designated Flood			-122.018354 °
Item	Revetments			
DWR ID	DWR_NA0035_15_c_2012_9			
Action/Comments				
Inspector Comments: Existing riprap protection is properly maintained and is undamaged. Riprap clearly visible.

View of revetment on the right bank looking downstream towards pilot channel. Summer 2017.

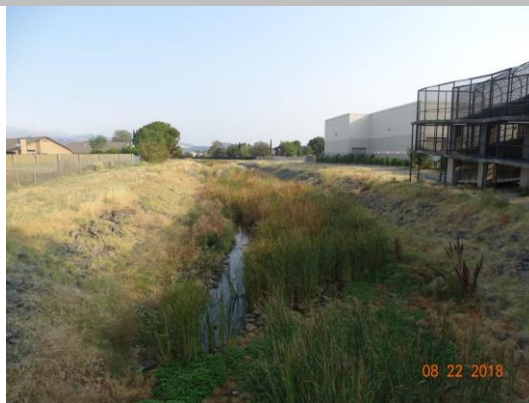
Photo 1 of 4 : CH_2018_NA0035_15_11_20180823_00085.jpg

View of the channel looking upstream. Summer 2018.

Inspector Comments: Clear tules from the channel.

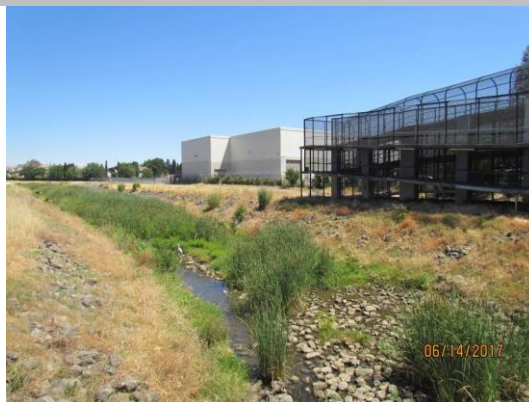
Photo 2 of 4 : CH_2018_NA0035_15_11_20180529_00011.jpg

View of creek looking upstream from Air Base Parkway. Summer 2017.

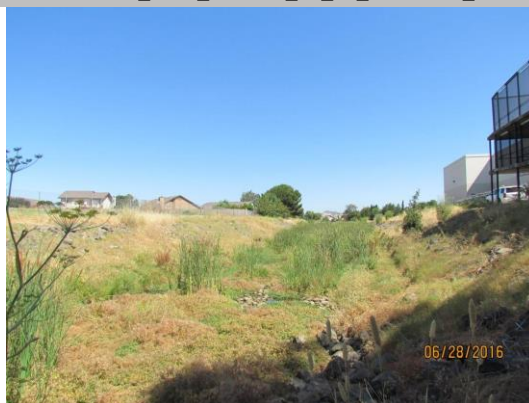
Photo 3 of 4 : CH_2018_NA0035_15_11_20180529_00012.jpg

View of the creek looking upstream towards Cement Hill Rd. Summer 2016.

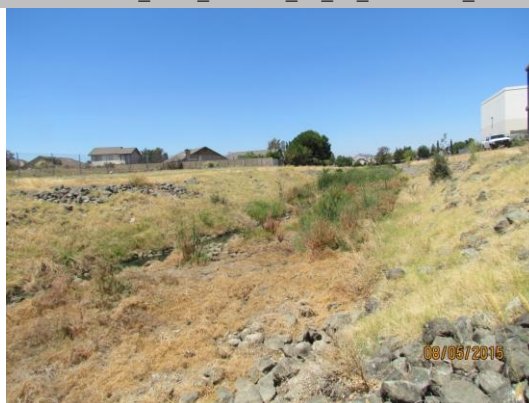
Photo 4 of 4 : CH_2018_NA0035_15_11_20180529_00013.jpg

Looking upstream from Air Base Parkway. Summer 2015.

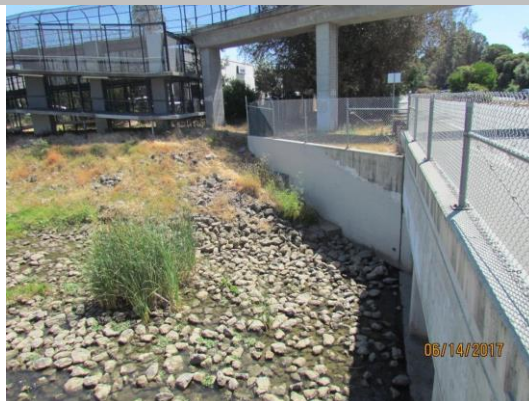
Photo 1 of 1 : CH_2018_NA0035_15_14_20180529_00014.jpg

Inspector Comments: Existing riprap protection is properly maintained and is undamaged. Riprap clearly visible.

View of revetment on left bank, looking upstream. Summer 2017.

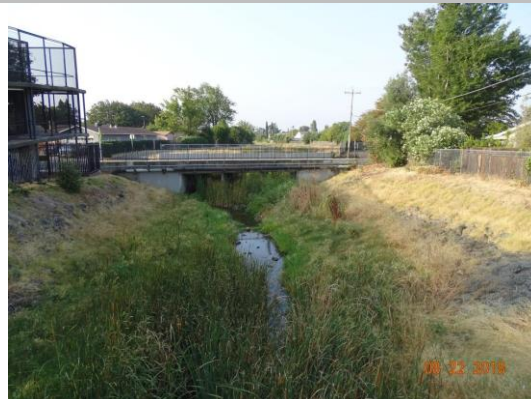
Photo 1 of 4 : CH_2018_NA0035_15_16_20180823_00084.jpg

Inspector Comments: Minimal, scattered obstructions or vegetation. The flow is not impeded.

View of the channel looking downstream. Summer 2018.

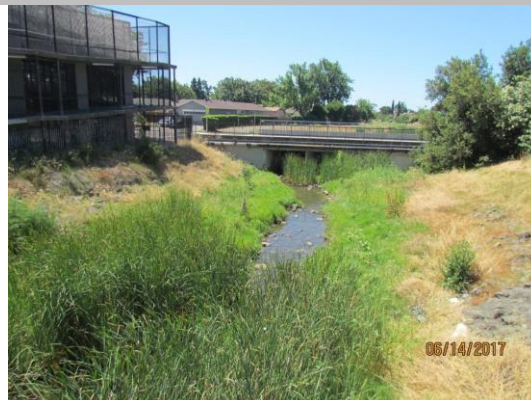
Photo 2 of 4 : CH_2018_NA0035_15_16_20180529_00015.jpg

View of creek looking downstream. Summer 2017.

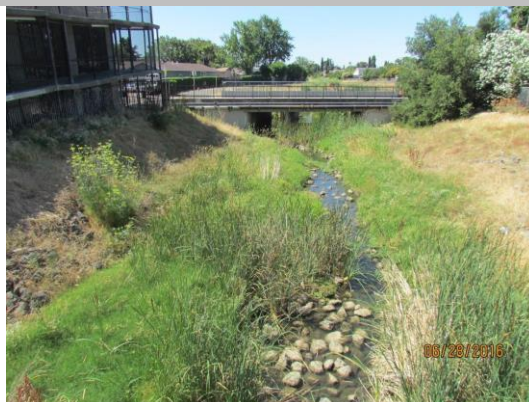
Photo 3 of 4 : CH_2018_NA0035_15_16_20180529_00016.jpg

Rating **	A	Issue No.	16 (cont)	GPS Lat/Long
Issue Type +	Ma	Location *		38.272633 °
Category	Rivers, Channels & Designated Flood			-122.016110 °
Item	Vegetation & Obstructions			
DWR ID	DWR_NA0035_15_c_2012_16			
Action/Comments				
Inspector Comments: Minimal, scattered obstructions or vegetation. The flow is not impeded.

View of the creek looking downstream towards Nightengale Dr. Summer 2016.

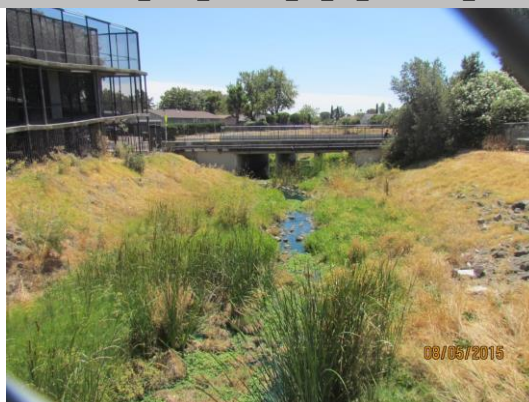
Photo 4 of 4 : CH_2018_NA0035_15_16_20180529_00017.jpg

Looking downstream from Air Base Pkwy. Summer 2015.

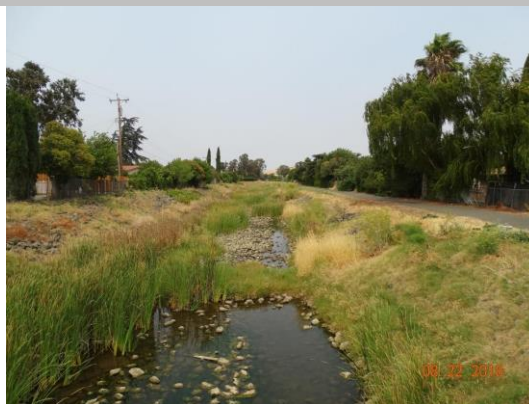
Photo 1 of 4 : CH_2018_NA0035_15_21_20180823_00083.jpg

View of the channel looking upstream. Summer 2018.

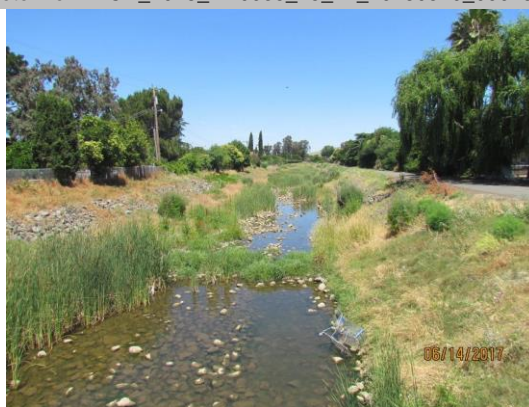
Photo 2 of 4 : CH_2018_NA0035_15_21_20180529_00018.jpg

View of the channel looking upstream. Summer 2017.

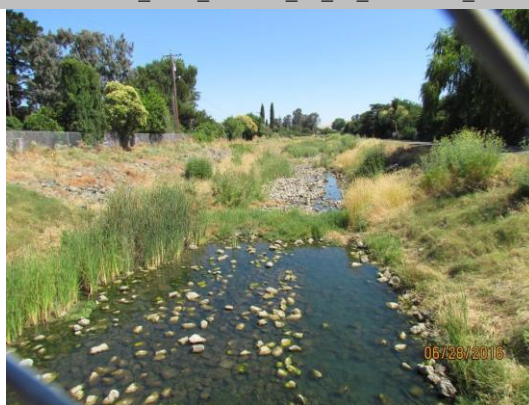
Photo 3 of 4 : CH_2018_NA0035_15_21_20180529_00019.jpg

View of the creek looking upstream towards Air Base Pkwy. Summer 2016.

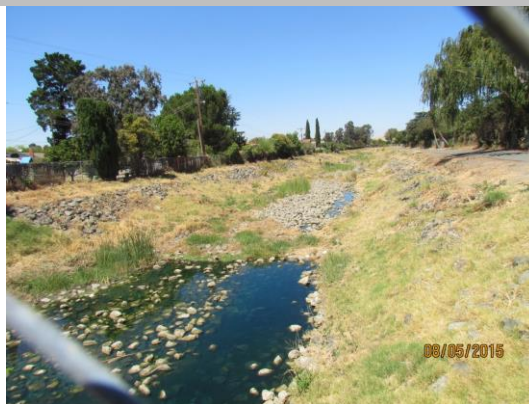
Photo 4 of 4 : CH_2018_NA0035_15_21_20180529_00020.jpg

Inspector Comments: Minimal, scattered obstructions or vegetation. The flow is not impeded.

Looking upstream from Meadowlark Dr. Summer 2015.

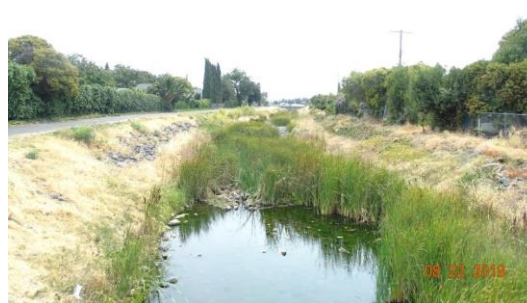
Photo 1 of 4 : CH_2018_NA0035_15_26_20180823_00082.jpg

Inspector Comments: Minimal, scattered obstructions or vegetation. The flow is not impeded.

View of the channel looking downstream. Summer 2018.

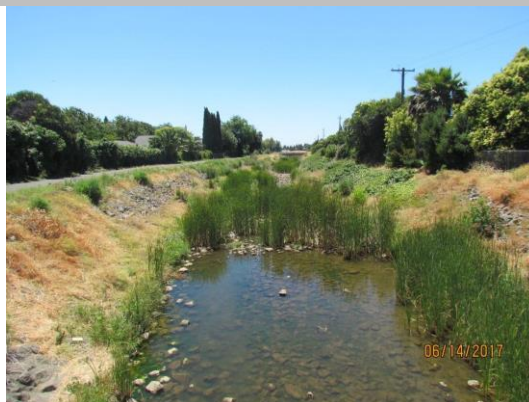
Photo 2 of 4 : CH_2018_NA0035_15_26_20180529_00021.jpg

View of the channel looking downstream. Summer 2017.

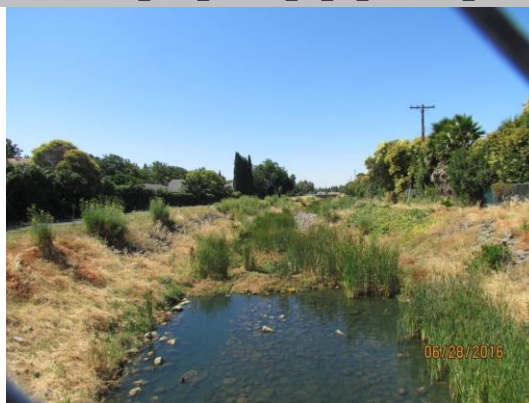
Photo 3 of 4 : CH_2018_NA0035_15_26_20180529_00022.jpg

View of the creek looking downstream from Meadowlark Dr. towards E. Tabor Ave. Summer 2016.

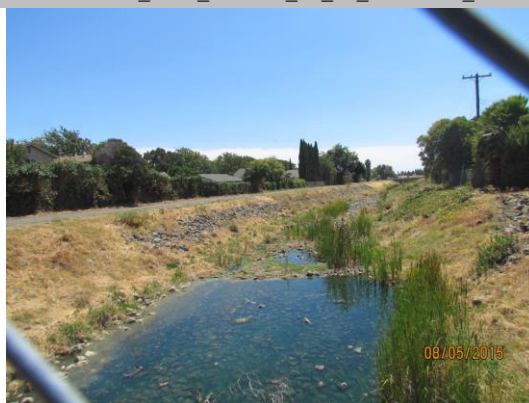
Photo 4 of 4 : CH_2018_NA0035_15_26_20180529_00023.jpg

Looking downstream from Meadowlark Dr. Summer 2015.

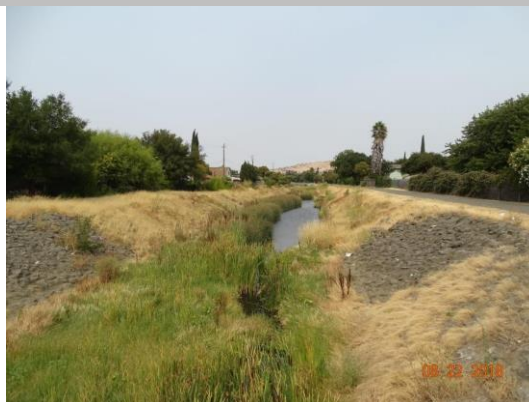
Photo 1 of 4 : CH_2018_NA0035_15_31_20180823_00081.jpg

Inspector Comments: Minimal, scattered obstructions or vegetation. The flow is not impeded.

View of the channel looking upstream. Summer 2018.

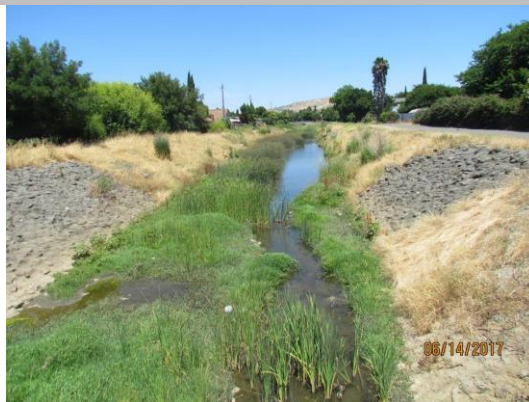
Photo 2 of 4 : CH_2018_NA0035_15_31_20180529_00025.jpg

View of the channel looking upstream. Summer 2017.

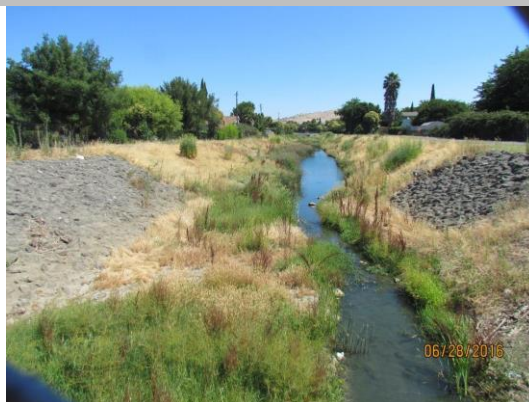
Photo 3 of 4 : CH_2018_NA0035_15_31_20180529_00026.jpg

Rating **	A	Issue No.	31 (cont)	GPS Lat/Long
Issue Type +	Ma	Location *		38.265401 °
Category	Rivers, Channels & Designated Flood			-122.018316 °
Item	Vegetation & Obstructions			
DWR ID	DWR_NA0035_15_c_2012_31			
Action/Comments				
Inspector Comments: Minimal, scattered obstructions or vegetation. The flow is not impeded.

View of the channel looking upstream from E. Tabor Ave. looking towards Meadowlark Dr. Summer 2016.

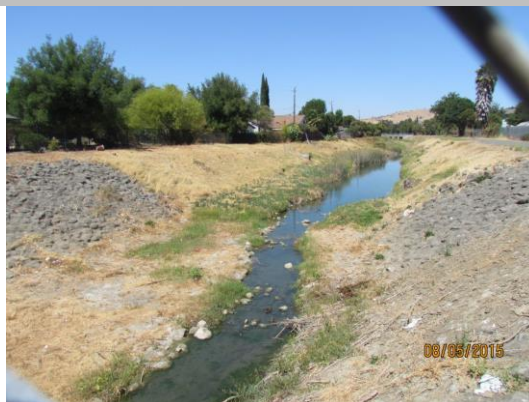
Photo 4 of 4 : CH_2018_NA0035_15_31_20180529_00027.jpg

Looking upstream from E. Tabor Ave. Woody vegetation has been removed. Summer 2015.

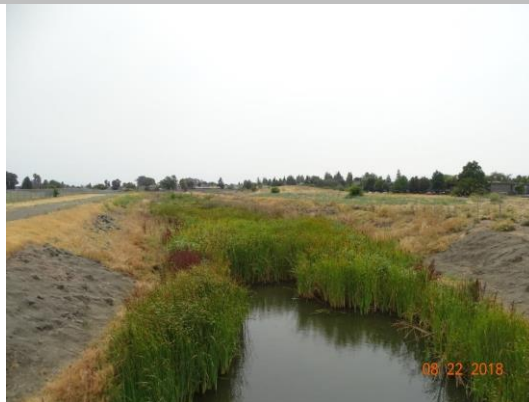
Photo 1 of 4 : CH_2018_NA0035_15_36_20180823_00080.jpg

View of the channel looking downstream. Summer 2018.

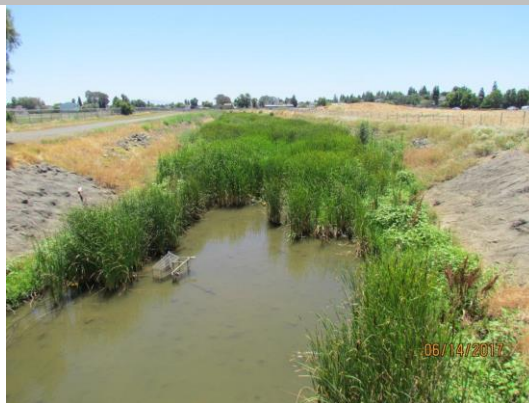
Photo 2 of 4 : CH_2018_NA0035_15_36_20180529_00028.jpg

View of the channel looking downstream. Summer 2017.

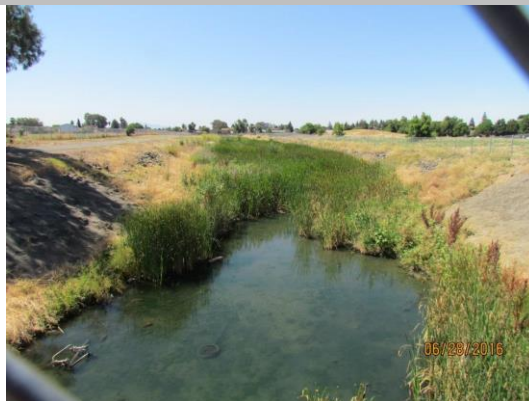
Photo 3 of 4 : CH_2018_NA0035_15_36_20180529_00029.jpg

View of the channel looking downstream towards Matthew Dr. from E. Tabor Ave. Summer 2016.

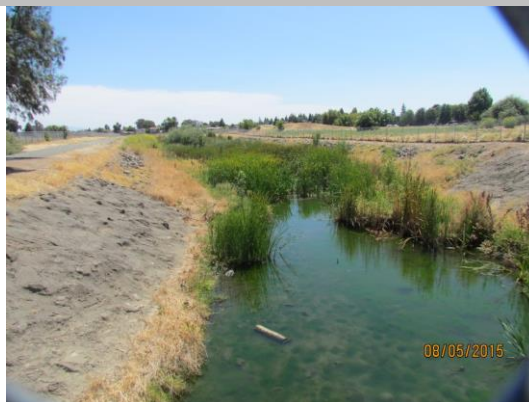
Photo 4 of 4 : CH_2018_NA0035_15_36_20180529_00030.jpg

Looking downstream from E. Tabor Ave. Summer 2015.

Rating **	M	Issue No.	36 (cont)	GPS Lat/Long
Issue Type +	Ma	Location *		38.265401 °
Category	Rivers, Channels & Designated Flood			-122.018316 °
Item	Vegetation & Obstructions			
DWR ID	DWR_NA0035_15_c_2012_36			
Action/Comments				
Inspector Comments: Clear tules from channel.

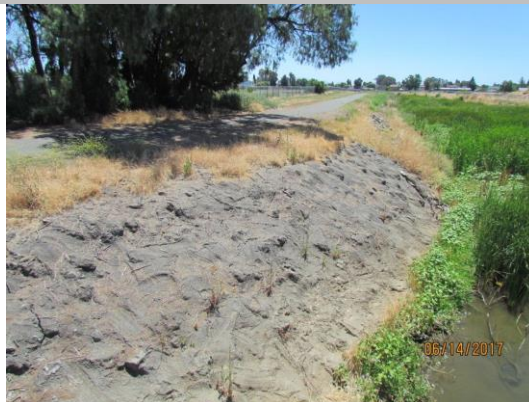
Photo 1 of 1 : CH_2018_NA0035_15_39_20180529_00031.jpg

Inspector Comments: Existing riprap protection is properly maintained and is undamaged. Riprap clearly visible.

View of revetment on left bank, looking downstream. Summer 2017.

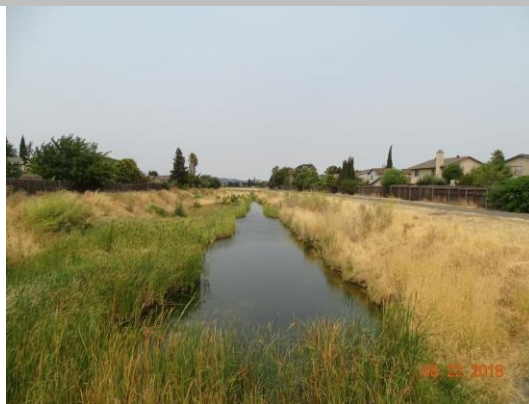
Photo 1 of 4 : CH_2018_NA0035_15_41_20180823_00079.jpg

View of the channel looking upstream. Summer 2018.

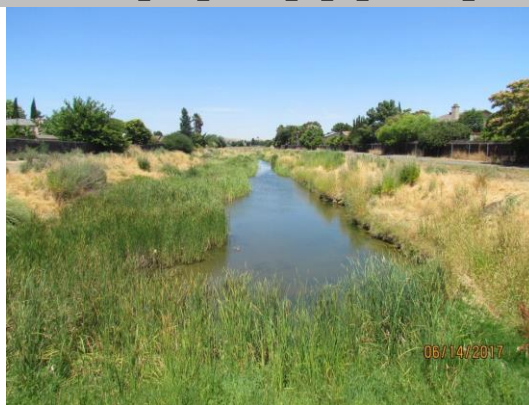
Photo 3 of 4 : CH_2018_NA0035_15_41_20180529_00033.jpg

View of the channel looking upstream towards East Tabor Ave. from Matthew Rd. Summer 2016.

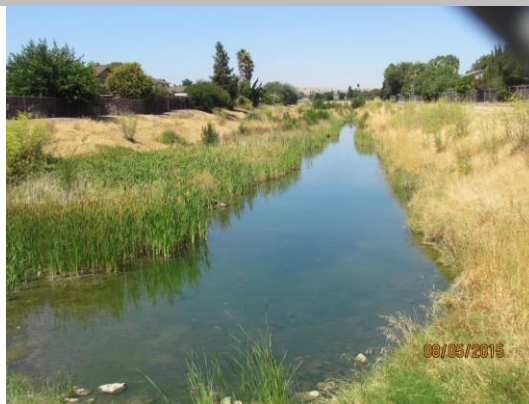
Photo 4 of 4 : CH_2018_NA0035_15_41_20180529_00034.jpg

Rating **	A	Issue No.	41 (cont)	GPS Lat/Long
Issue Type +	Ma	Location *		38.259229 °
Category	Rivers, Channels & Designated Flood			-122.017713 °
Item	Vegetation & Obstructions			
DWR ID	DWR_NA0035_15_c_2012_41			
Action/Comments				
Inspector Comments: Minimal, scattered obstructions or vegetation. The flow is not impeded.

Looking upstream from Matthew Rd. Summer 2015.

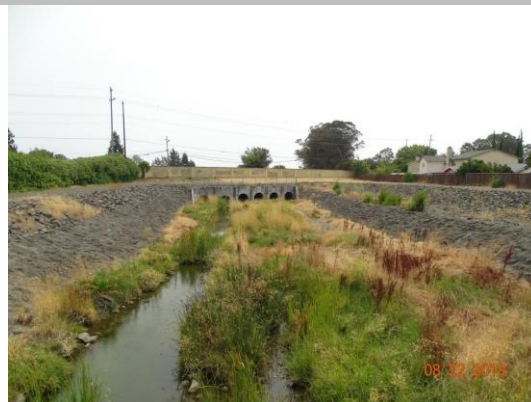
Photo 1 of 4 : CH_2018_NA0035_15_46_20180823_00077.jpg

Inspector Comments: Minimal, scattered obstructions or vegetation. The flow is not impeded.

View of the channel looking downstream. Summer 2018.

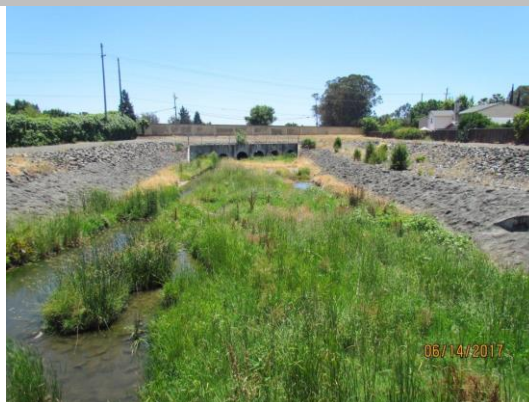
Photo 2 of 4 : CH_2018_NA0035_15_46_20180529_00036.jpg

Inspector Comments: Minimal, scattered obstructions or vegetation. The flow is not impeded.

View of the channel looking downstream. Summer 2017.

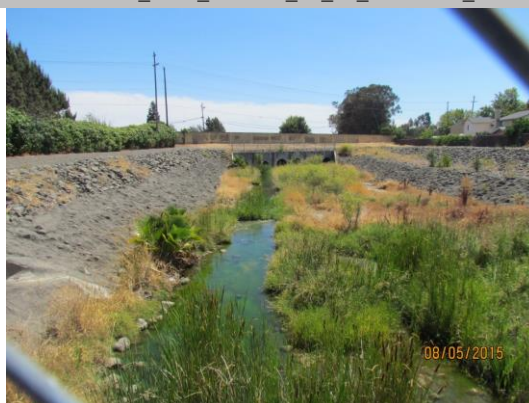
Photo 4 of 4 : CH_2018_NA0035_15_46_20180529_00038.jpg

Looking downstream from Matthews Rd. Pipe goes under the railroad. Summer 2015.

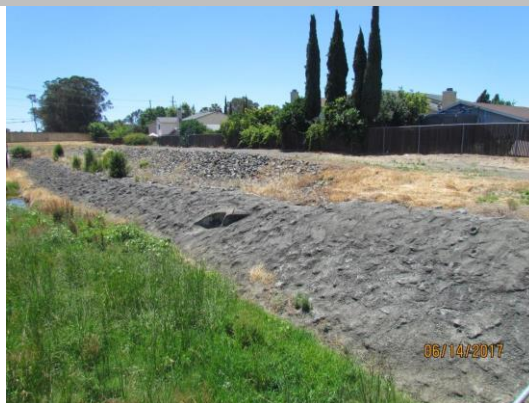
Photo 1 of 1 : CH_2018_NA0035_15_49_20180529_00039.jpg

Rating **	A	Issue No.	49	GPS Lat/Long
Issue Type +	Ma	Location *		38.259230 °
Category	Rivers, Channels & Designated Flood			-122.017714 °
Item	Revetments			
DWR ID	DWR_NA0035_15_c_2012_49			
Action/Comments				
Inspector Comments: Existing riprap protection is properly maintained and is undamaged. Riprap clearly visible.

View of revetment on right bank, looking downstream. Summer 2017.

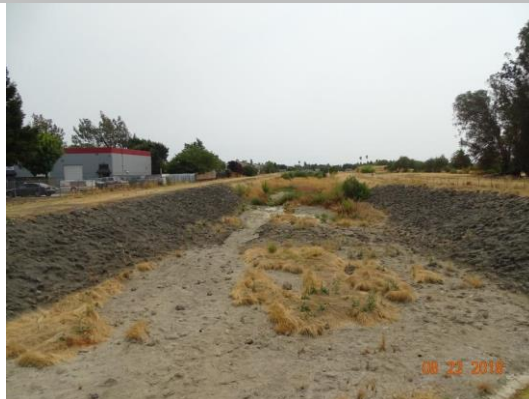
Photo 1 of 4 : CH_2018_NA0035_15_56_20180823_00076.jpg

Inspector Comments: Minimal scattered obstruction or vegetation. The flow is not impeded.

View of the channel looking downstream. Summer 2018.

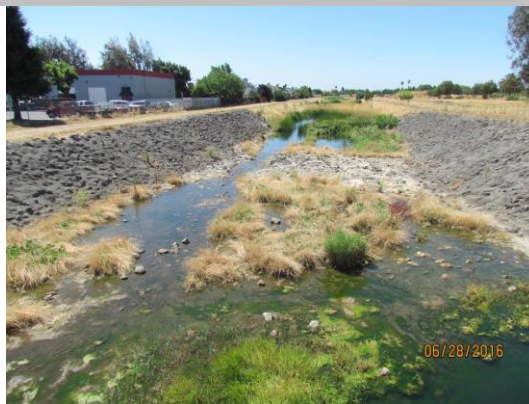
Photo 3 of 4 : CH_2018_NA0035_15_56_20180529_00041.jpg

Rating **	A	Issue No.	56 (cont)	GPS Lat/Long
Issue Type +	Ma	Location *		38.257784 °
Category	Rivers, Channels & Designated Flood			-122.017733 °
Item	Vegetation & Obstructions			
DWR ID	DWR_NA0035_15_c_2012_56			
Action/Comments				
Inspector Comments: Minimal scattered obstruction or vegetation. The flow is not impeded.

View of the channel looking downstream from Railroad Ave. Summer 2016.

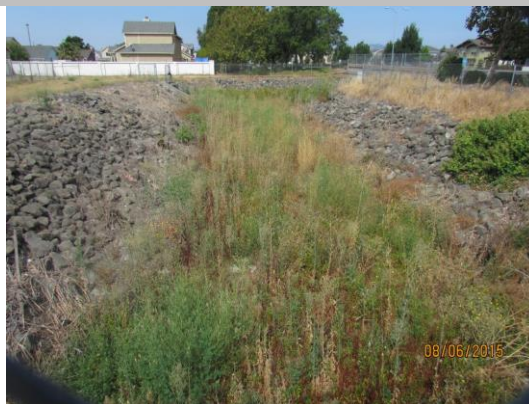
Photo 4 of 4 : CH_2018_NA0035_15_61_20180529_00045.jpg

Inspector Comments: Minimal scattered obstructions or vegetation. The flow is not impeded.

Looking upstream from Sunset Ave. Summer 2015.

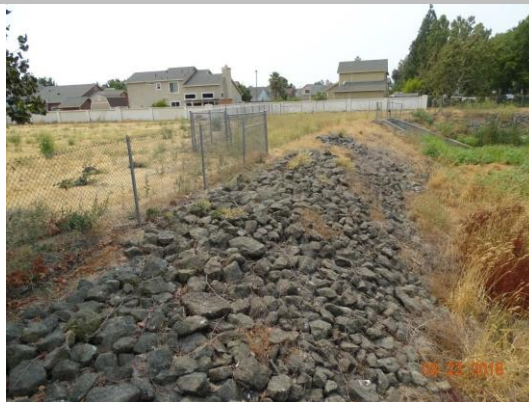
Photo 1 of 3 : CH_2018_NA0035_15_64_20180823_00078.jpg

Inspector Comments: Existing riprap protection is properly maintained and is undamaged. Riprap clearly visible.

View of the revetment on the right bank, looking upstream. Summer 2018.

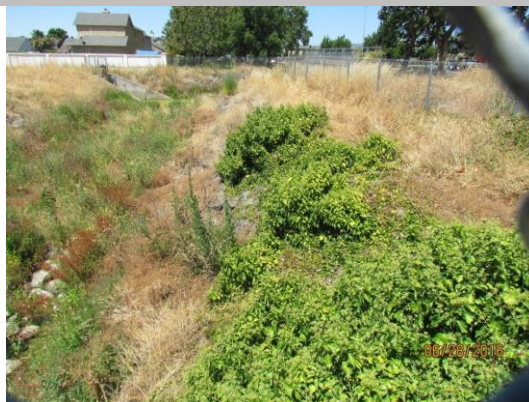
Photo 2 of 3 : CH_2018_NA0035_15_64_20180529_00046.jpg

View of the vegetation on the revetment on the left bank looking upstream. Summer 2016.

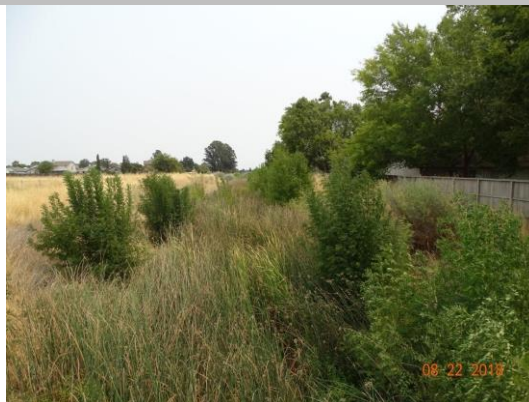
Photo 1 of 4 : CH_2018_NA0035_15_66_20180823_00074.jpg

Rating **	M	Issue No.	66	GPS Lat/Long
Issue Type +	Ma	Location *		38.253525 °
Category	Rivers, Channels & Designated Flood			-122.019984 °
Item	Vegetation & Obstructions			
DWR ID	DWR_NA0035_15_c_2012_66			
Action/Comments				
Inspector Comments: Vegetation growth (such as cat tails, bull rushes, bushes or saplings) or other obstructions block approximately 25% of the FCW.

View of the channel looking downstream. Summer 2018.

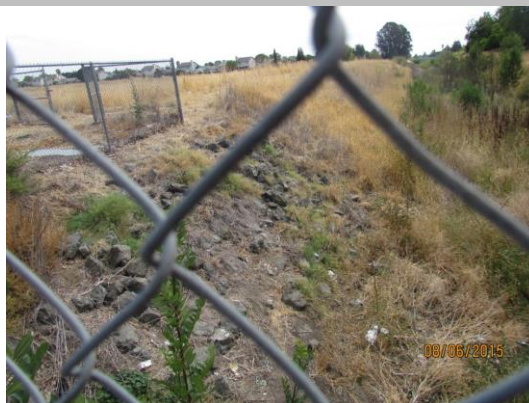
Photo 1 of 2 : CH_2018_NA0035_15_69_20180529_00052.jpg

Rating **	A	Issue No.	69	GPS Lat/Long
Issue Type +	Ma	Location *		38.253525 °
Category	Rivers, Channels & Designated Flood			-122.019984 °
Item	Revetments			
DWR ID	DWR_NA0035_15_c_2017_69			
Action/Comments				
Inspector Comments: No riprap displacement or scouring activity.

View of the revetment on the left bank looking downstream from Sunset Ave. Summer 2015.

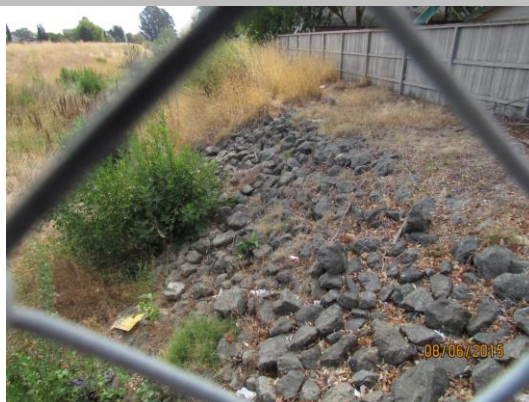
Photo 2 of 2 : CH_2018_NA0035_15_69_20180529_00053.jpg

Inspector Comments: No riprap displacement or scouring activity.

View of the revetment on the right bank looking downstream from Sunset Ave. Summer 2015.

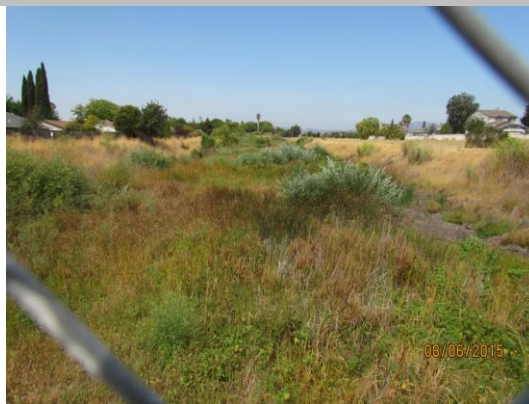
Photo 4 of 4 : CH_2018_NA0035_15_71_20180529_00056.jpg

Inspector Comments: Vegetation growth, cat tails, bushes, or saplings block 25% of the channel.

Looking upstream from Blossom Rd. Summer 2015.

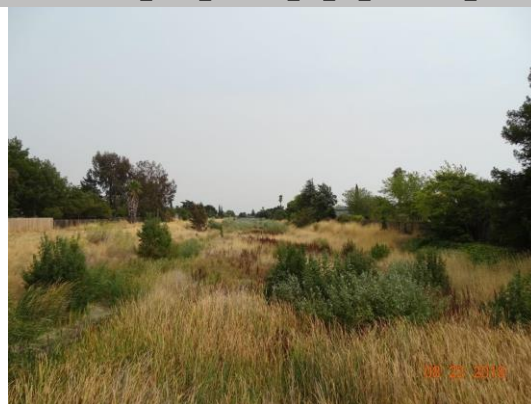
Photo 1 of 4 : CH_2018_NA0035_15_76_20180823_00072.jpg

View of the channel looking downstream. Summer 2018.

Inspector Comments: Clear tules and other woody vegetation from the channel.

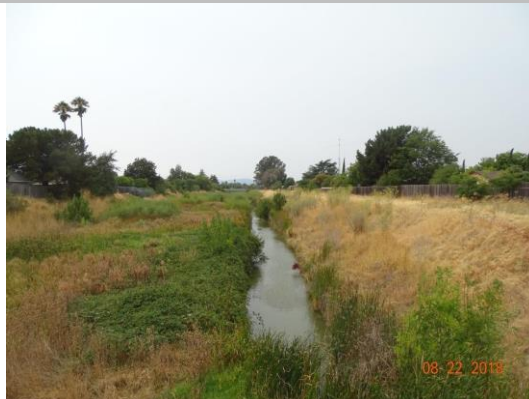
Photo 1 of 4 : CH_2018_NA0035_15_81_20180823_00071.jpg

Inspector Comments: Minimal, scattered obstructions or vegetation. The flow is not impeded.

View of the channel looking upstream. Summer 2018.

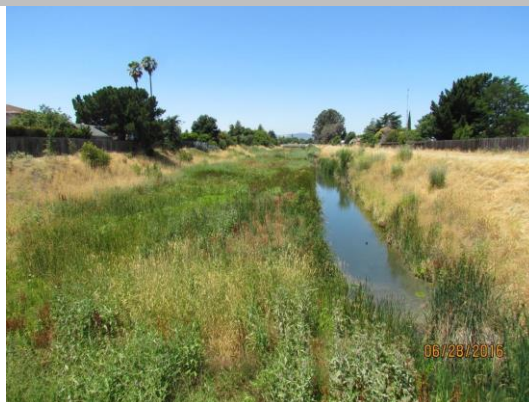
Photo 3 of 4 : CH_2018_NA0035_15_81_20180529_00062.jpg

Inspector Comments: Minimal, scattered obstructions or vegetation. The flow is not impeded.

View of the channel looking upstream towards Blossom Rd. from Worley Rd. Summer 2016.

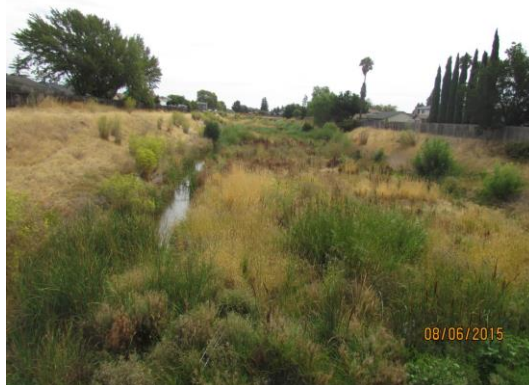
Photo 4 of 4 : CH_2018_NA0035_15_86_20180529_00066.jpg

Inspector Comments: Vegetation growth (such as cat tails, bull rushes, bushes or saplings) or other obstructions block approximately 25% of the FCW.

Looking downstream from Worley Road. Suggest removal of woody vegetation. Summer 2015.

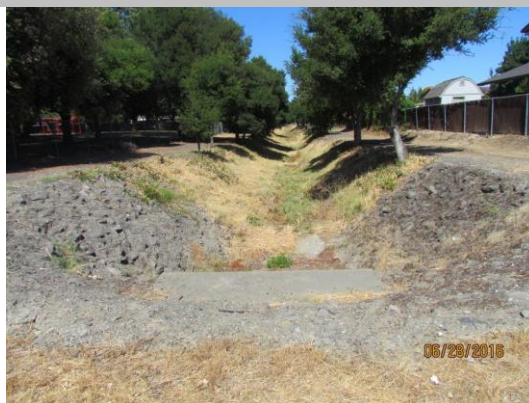
Photo 3 of 4 : CH_2018_NA0035_17_1_20180529_00002.jpg

View of the channel looking upstream from Astoria Dr. Summer 2016.

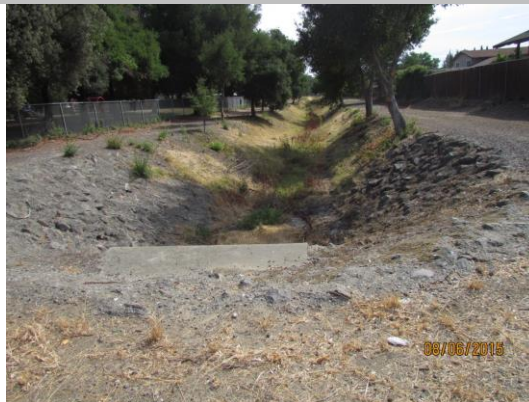
Photo 4 of 4 : CH_2018_NA0035_17_1_20180529_00003.jpg

Rating **	A	Issue No.	1 (cont)	GPS Lat/Long
Issue Type +	Ma	Location *		38.256296 °
Category	Rivers, Channels & Designated Flood			-122.073705 °
Item	Vegetation & Obstructions			
DWR ID	DWR_NA0035_17_c_2012_1			
Action/Comments				
Inspector Comments: Minimal, scattered obstructions or vegetation.

Looking upstream from Astoria Dr. Trees have been trimmed. Summer 2015.

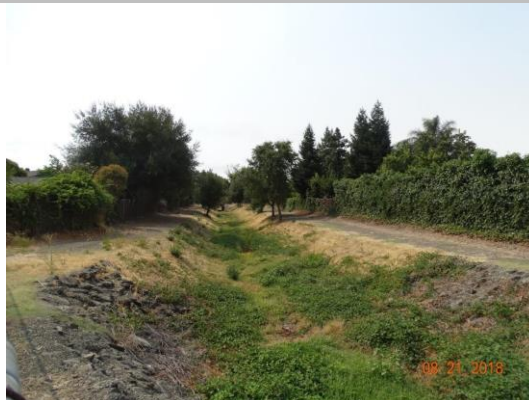
Photo 1 of 4 : CH_2018_NA0035_17_6_20180823_00072.jpg

Inspector Comments: Minimal, scattered obstructions or vegetation. The flow is not impeded.

View of the channel looking downstream. Summer 2018.

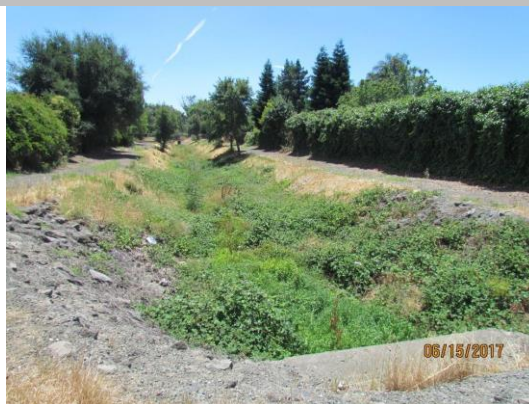
Photo 2 of 4 : CH_2018_NA0035_17_6_20180529_00004.jpg

View of the channel looking downstream. Summer 2017.

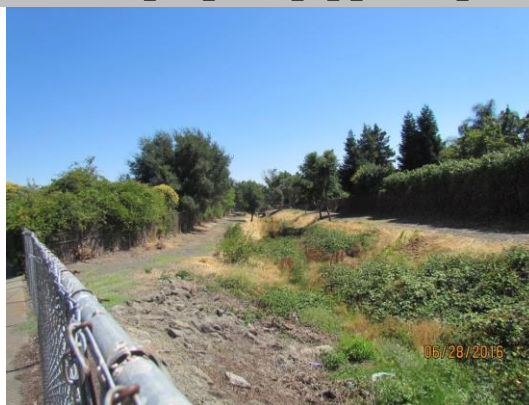
Photo 3 of 4 : CH_2018_NA0035_17_6_20180529_00005.jpg

View of the channel looking downstream from Astoria Dr. Summer 2016.

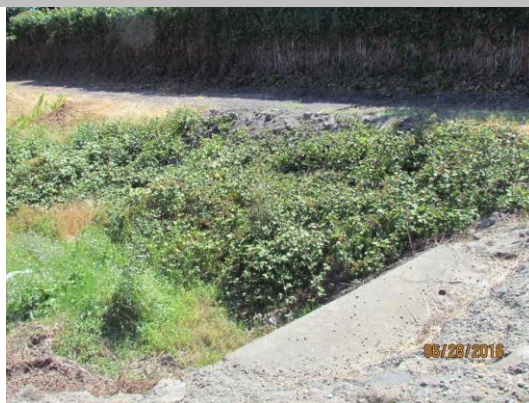
Photo 4 of 4 : CH_2018_NA0035_17_6_20180529_00006.jpg

Blackberries on the downstream side of Astoria Dr. need to be removed. Summer 2016.

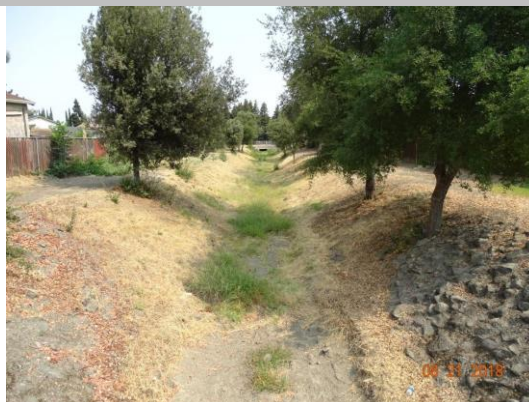
Photo 1 of 4 : CH_2018_NA0035_17_11_20180823_00071.jpg

Check Point / View				
Springfield Dr. / Up				
Rating **	A	Issue No.	11	GPS Lat/Long
Issue Type +	Ma	Location *		38.254594 °
Category	Rivers, Channels & Designated Flood			-122.073608 °
Item	Vegetation & Obstructions			
DWR ID	DWR_NA0035_17_c_2012_11			
Action/Comments				
Inspector Comments: Minimal, scattered obstructions or vegetation. The flow is not impeded.

View of the channel looking upstream. Summer 2018.

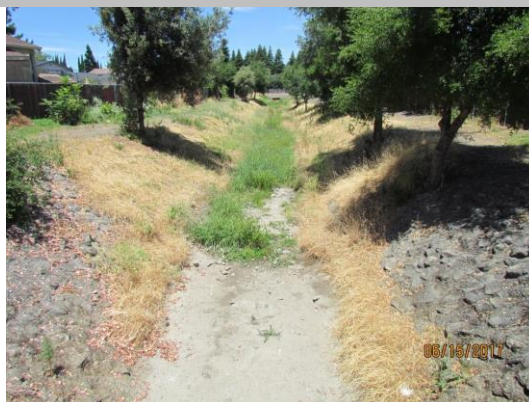
Photo 2 of 4 : CH_2018_NA0035_17_11_20180529_00008.jpg

View of the channel looking upstream. Summer 2017.

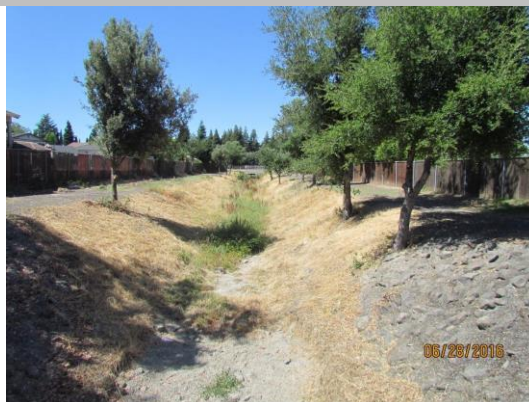
Photo 3 of 4 : CH_2018_NA0035_17_11_20180529_00009.jpg

Inspector Comments: Minimal, scattered obstructions or vegetation. The flow is not impeded.

View of the channel looking upstream from Springfield Dr. Summer 2016.

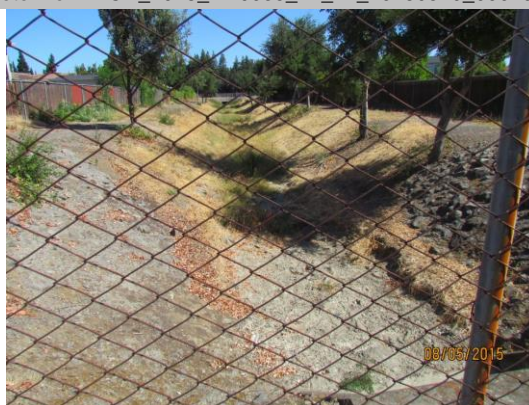
Photo 4 of 4 : CH_2018_NA0035_17_11_20180529_00010.jpg

Looking upstream from Springfield Dr. Summer 2015.

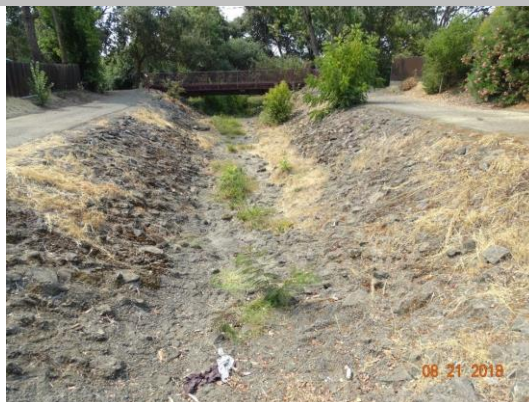
Photo 1 of 4 : CH_2018_NA0035_17_16_20180823_00070.jpg

View of the channel looking downstream. Summer 2018.

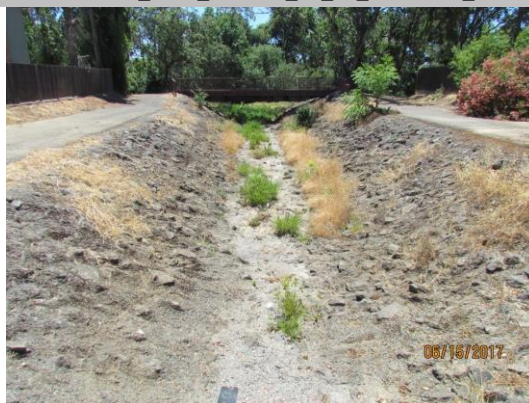
Photo 2 of 4 : CH_2018_NA0035_17_16_20180529_00011.jpg

View of the channel looking downstream. Summer 2017.

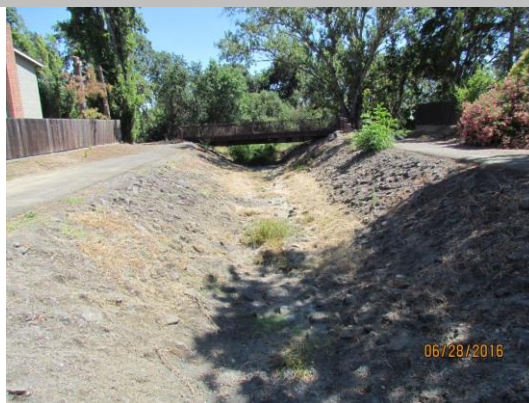
Photo 3 of 4 : CH_2018_NA0035_17_16_20180529_00012.jpg

View of the channel looking downstream from Springfield Dr. Summer 2016.

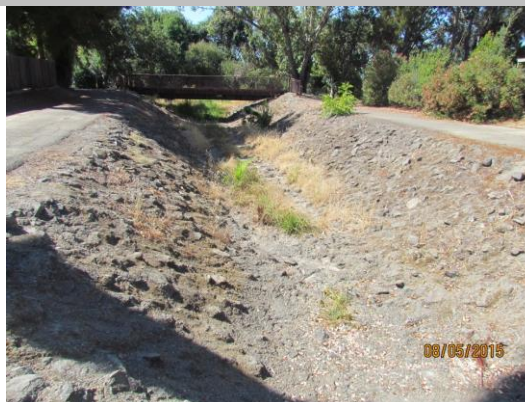
Photo 4 of 4 : CH_2018_NA0035_17_16_20180529_00013.jpg

Inspector Comments: Minimal, scattered obstructions or vegetation. The flow is not impeded.

Looking downstream from Springfield Dr. Summer 2015.

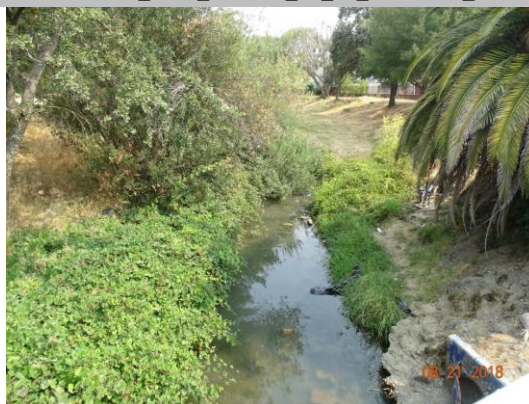
Photo 1 of 4 : CH_2018_NA0035_17_21_20180823_00069.jpg

Inspector Comments: Minimal, scattered obstructions or vegetation. The flow is not impeded.

View of the channel looking upstream. Summer 2018.

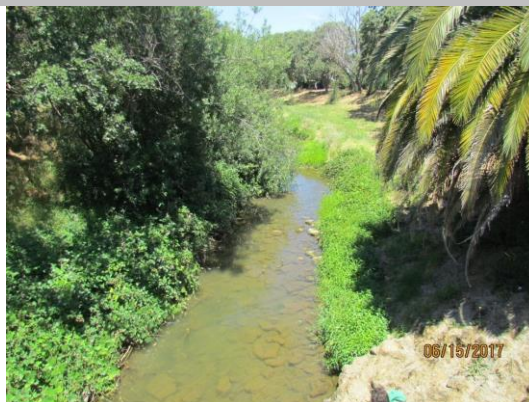
Photo 2 of 4 : CH_2018_NA0035_17_21_20180529_00014.jpg

Inspector Comments: Minimal, scattered obstructions or vegetation. The flow is not impeded.

View of the channel looking upstream. Summer 2017.

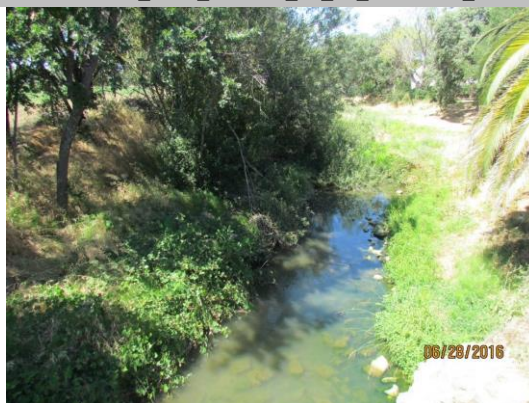
Photo 3 of 4 : CH_2018_NA0035_17_21_20180529_00015.jpg

View of the channel looking upstream from Rockville Rd. Summer 2016.

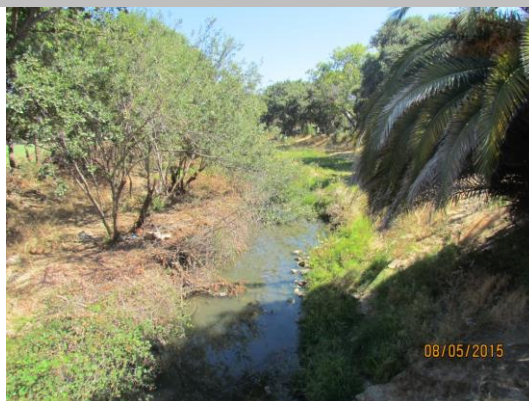
Photo 4 of 4 : CH_2018_NA0035_17_21_20180529_00016.jpg

Looking upstream from Rockville Rd. Summer 2015.

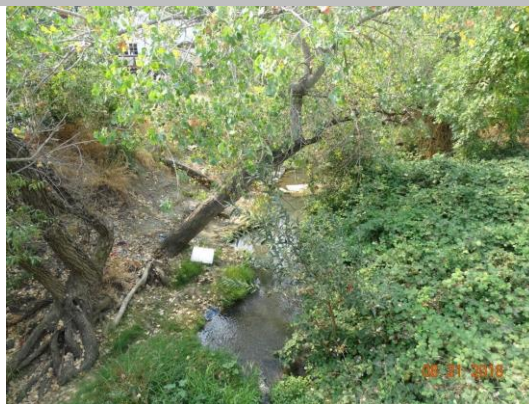
Photo 1 of 4 : CH_2018_NA0035_17_26_20180823_00068.jpg

View of the channel looking downstream. Summer 2018.

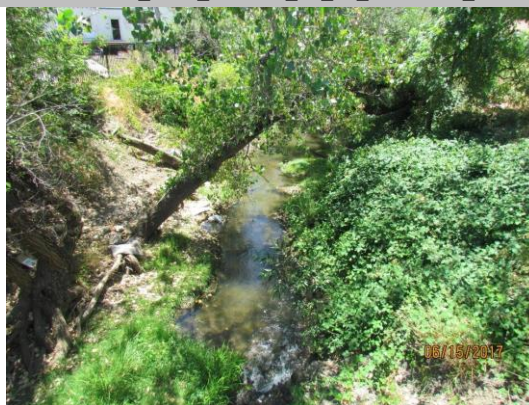
Photo 2 of 4 : CH_2018_NA0035_17_26_20180529_00018.jpg

View of the channel looking downstream. Summer 2017.

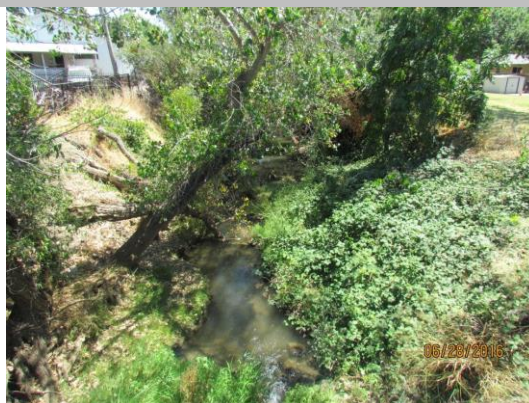
Photo 3 of 4 : CH_2018_NA0035_17_26_20180529_00019.jpg

View of the channel looking downstream from Rockville Rd. Summer 2016.

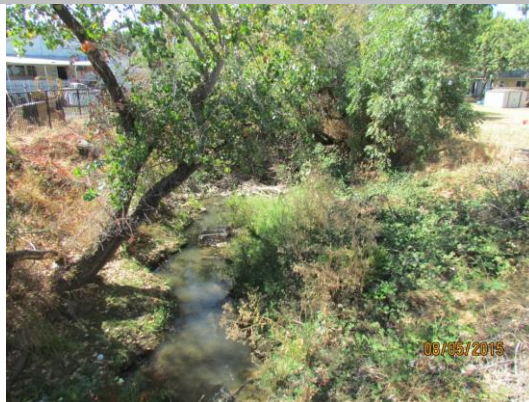
Photo 4 of 4 : CH_2018_NA0035_17_26_20180529_00020.jpg

Rating **	A	Issue No.	26 (cont)	GPS Lat/Long
Issue Type +	Ma	Location *		38.249840 °
Category	Rivers, Channels & Designated Flood			-122.072644 °
Item	Vegetation & Obstructions			
DWR ID	DWR_NA0035_17_c_2012_26			
Action/Comments				
Inspector Comments: Minimal, scattered obstructions or vegetation. The flow is not impeded.

Looking downstream from Rockville Rd. Summer 2015.

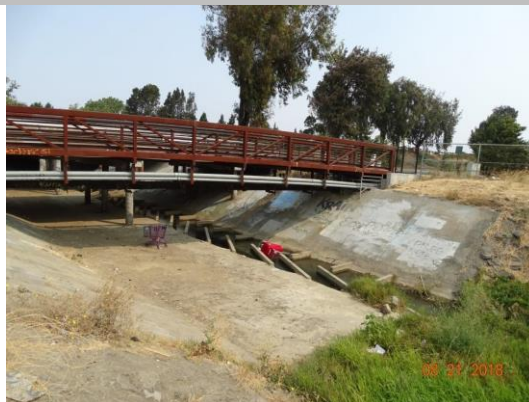
Photo 1 of 4 : CH_2018_NA0035_17_31_20180823_00067.jpg

Inspector Comments: Minimal, scattered obstructions or vegetation. The flow is not impeded.

View of the channel looking upstream. Summer 2018.

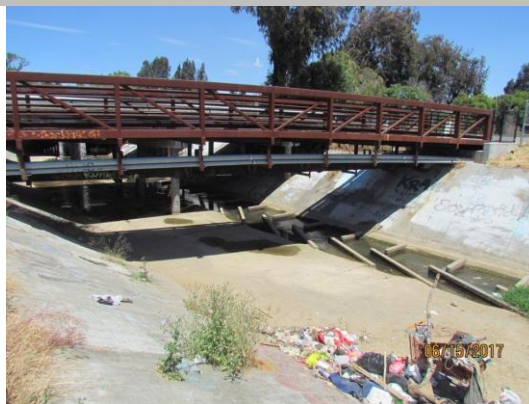
Photo 2 of 4 : CH_2018_NA0035_17_31_20180529_00021.jpg

View of the channel looking upstream. Summer 2017.

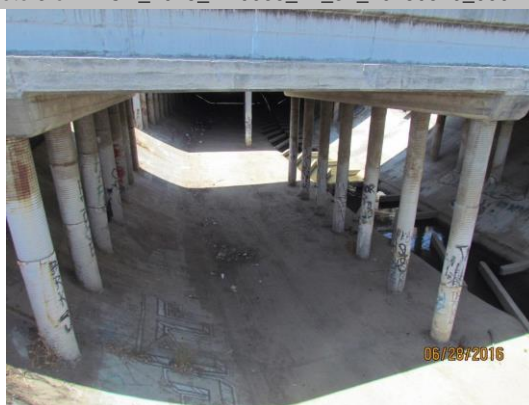
Photo 3 of 4 : CH_2018_NA0035_17_31_20180529_00022.jpg

View of the channel looking upstream from Auto Mall Pkwy. Summer 2016.

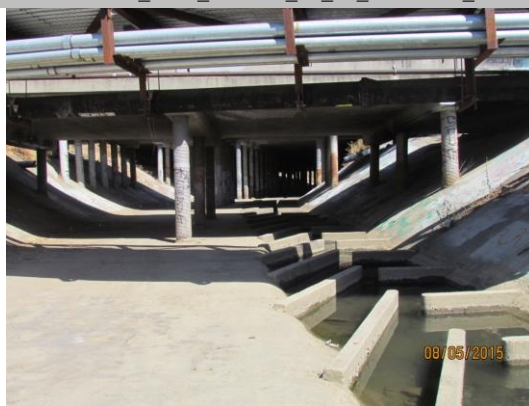
Photo 4 of 4 : CH_2018_NA0035_17_31_20180529_00023.jpg

Looking upstream from Auto Mall Pkwy under I-80. Summer 2015.
